Effect of Sandblasting on Low and High-Cycle Fatigue Behaviour after Mechanical Cutting of a Twinning-Induced Plasticity Steel

Antoni Lara^{1,*}, Mercè Roca¹, Sergi Parareda¹, Núria Cuadrado¹, Jessica Calvo² and Daniel Casellas^{1,3}

¹Fundació CTM Centre Tecnològic, Metallic and Ceramic Materials Department, 08243 Manresa, Spain

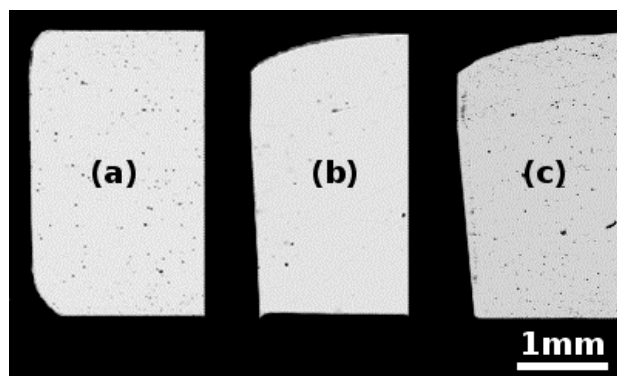
Fig. 5. TWIP3.0 cut edges: (a) REF, (b) CUT and (c) SAN.

The geometry of the edges was evaluated by cutting a specimen of each strategy in cross section and analysing them by optical microscopy, figure 4 and figure 5.

Sheet cut edges present different geometry depending on the cutting methodology employed. As shown in figure 4 and 5, polished samples present rounded edges without asperities, as expected (figure 4(a) and 5(a)). Sheared samples show the typical features of a sheared edge with rollover, smooth, fracture zones and burr in two materials (figure 4(b) and 5(b)). Once samples are submitted to the sandblasting operation, the roughness of the cutting edge is reduced and the burr removed.

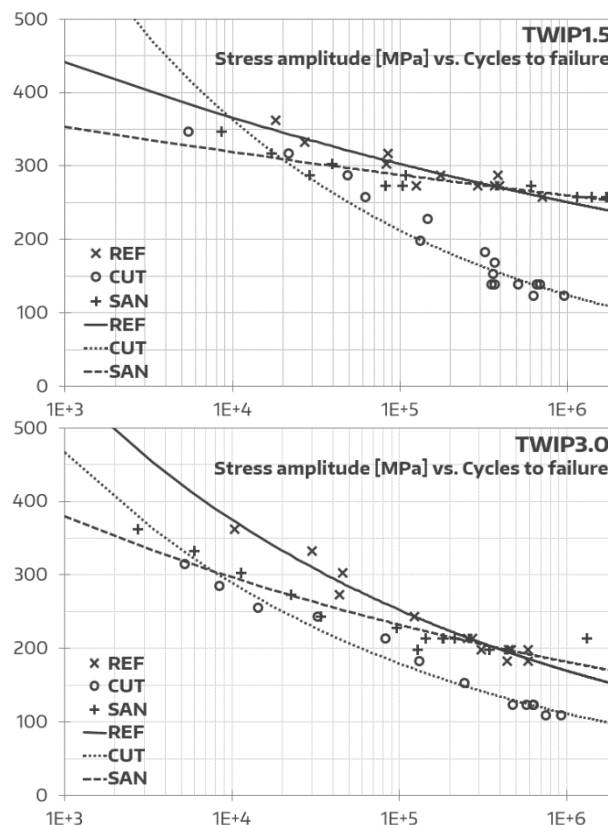
As shown in figure 8 and 9, fatigue performance depends on the cutting strategy employed. At low and high number of cycles (LCF and HCF tests), both strain and stress that can be applied for a given number of cycles, is higher for polished specimens compared with the sheared ones.

Concerning sandblasting specimens, the effect of this surface treatment on the fatigue performance depends on the applied stress level. Thus, the sandblasting process significantly increase the strain and stress-life behaviour when the stress level is low (low strain in LCF tests and low stress in HCF tests). On the contrary, at higher stress levels (high strain in LCF tests and high stress in HCF tests) sandblasting treatment does not introduce any noticeable improvement in the fatigue behaviour of this type of steels, since the fatigue results of sheared specimens are similar with and without sandblasting, at high stress levels.

Fig. 9. SN curves obtained with TWIP steels.

The main strain and stress-life fatigue results are summarized in figure 8 and 9, defined here as the strain and stress amplitude leading to 50% survival probability (experimental values).

These results may be explained as follows: sandblasting process to sheared specimens generates a compressive residual stress layer which is expected to influence the fatigue life. At low cyclic stresses, the favourable effects of the compressive residual stress layer results in life enhancement. As the cyclic stress increases, the residual stresses will relax quickly and the extent of life enhancement will decrease, as some authors support [21].

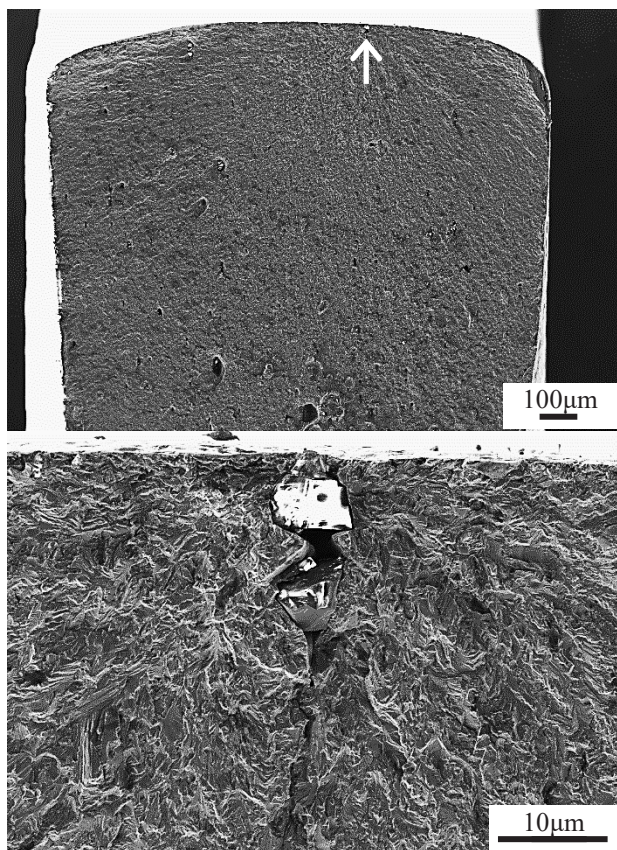
Fig. 10. Fractography of failed TWIP1.5 polished sample, showing the fatigue initiation site.

The fatigue failure surfaces in most cases show a failure origin independent of the cutting strategy, with no clear differences between the polished, sheared and sandblasted specimens. In most of the surface specimens analysed by SEM, the failure origin occurs in non-metallic inclusions located near the edge of the specimens.

Thus, to rationalize the origin of failure in each case, a detailed SEM investigation of one specimen of each cutting strategy was done. These SEM fractographies are shown in figures from 10 to 12 for TWIP1.5 and 13 to 15 for TWIP3.0.

These non-metallic inclusions, responsible for the crack nucleation, are probably the ones that cause that the fatigue performance of these two steels is not as high as expected. To know the nature of these non-metallic precipitates, an EDX analysis was performed, showing that most of them were aluminium nitrides.

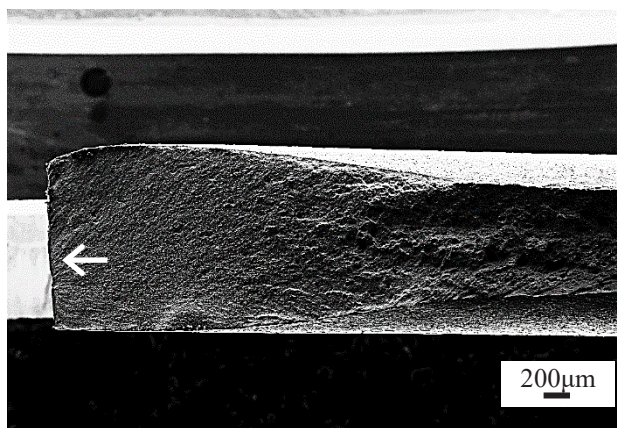
Fig. 11. Fractography of failed TWIP1.5 sheared sample, showing the fatigue initiation site.

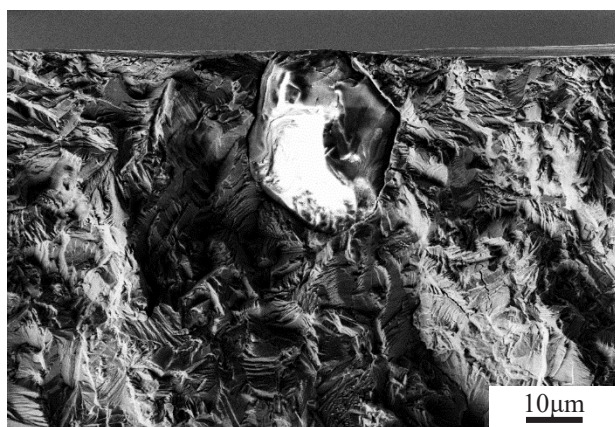
Fig. 13. Fractography of failed TWIP3.0 polished sample, showing the fatigue initiation site.

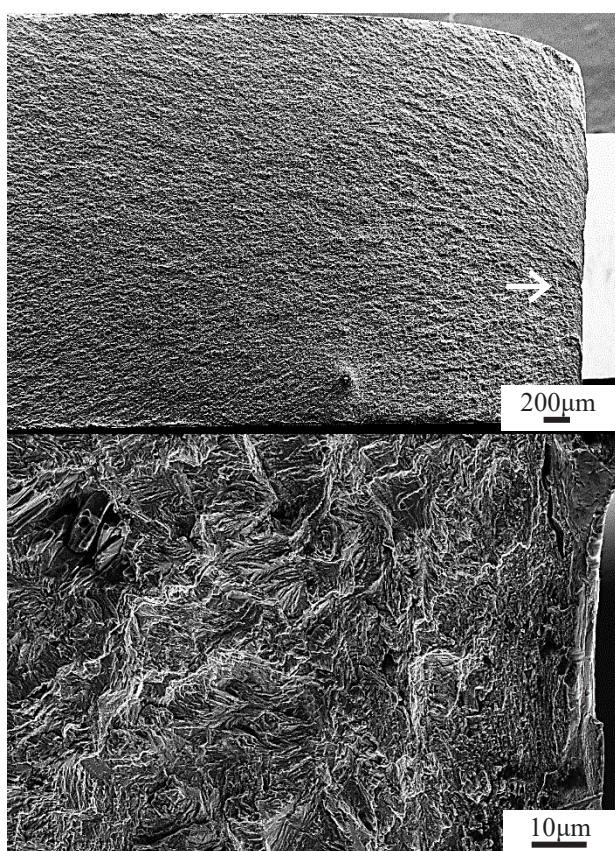
Fig. 14. Fractography of failed TWIP3.0 sheared sample, showing the fatigue initiation site.

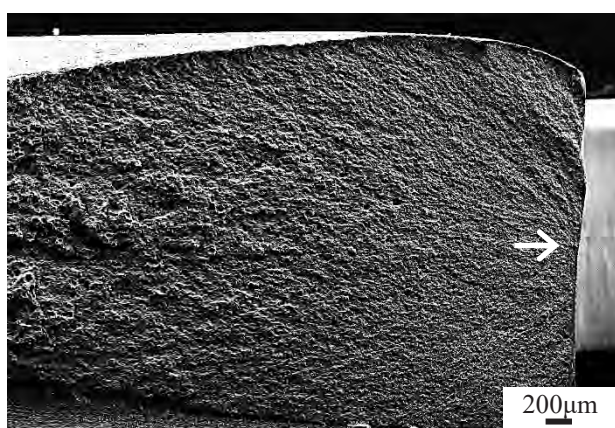
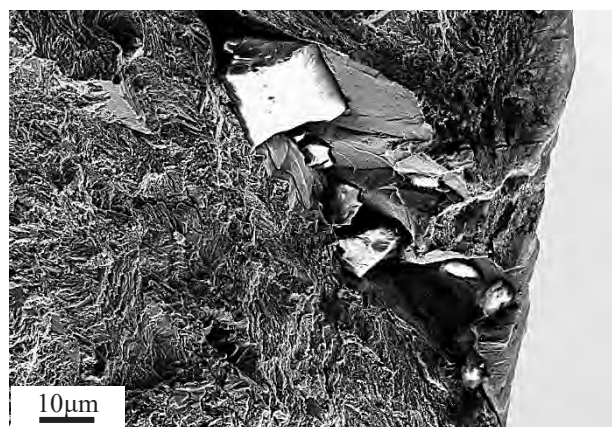
Fig. 15. Fractography of failed TWIP3.0 sheared and sandblasted sample, showing the fatigue initiation site.
